***Historical Description of  
RWMC Surrogate Buried Waste  
Test Pits  
for  
Environmental Restoration  
Waste Area Group 7  
OU 7-13/14***

*April 2002*

*Idaho National Engineering and Environmental Laboratory  
Bechtel BWXT Idaho, LLC*

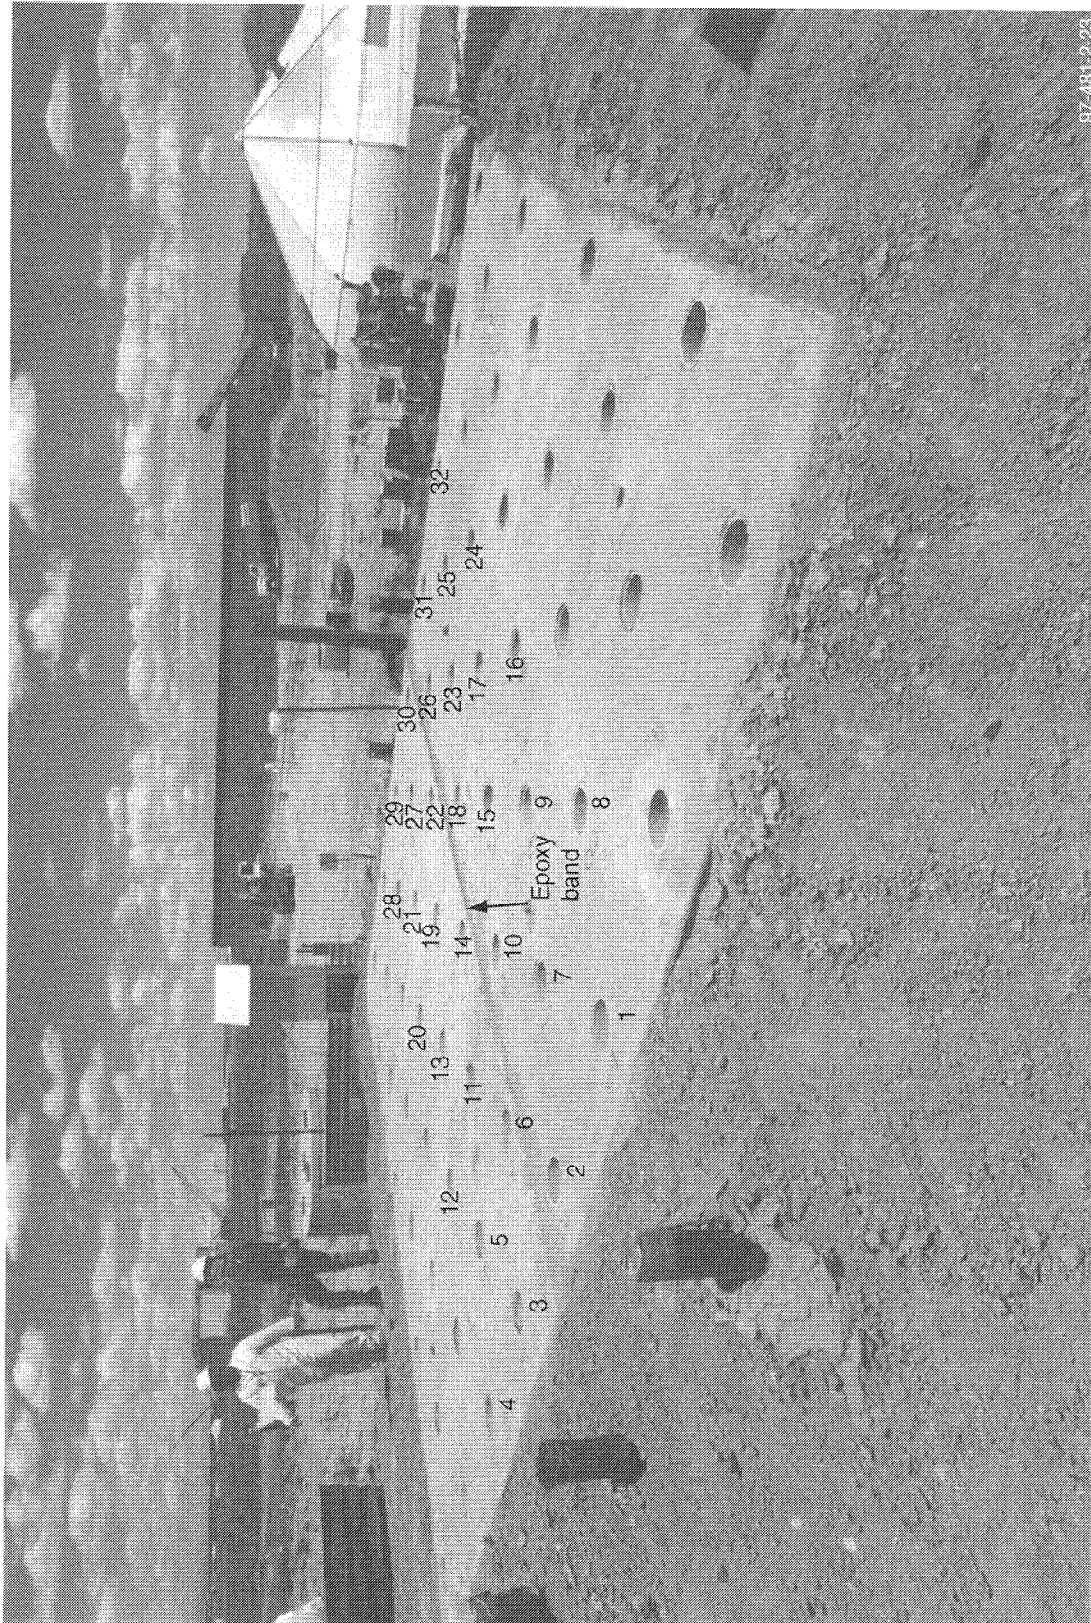
97-481-2-23

Details for the Soil Pit are identified in Acid Pit Stabilization Project volume 1 – Cold Testing (INEEL/EXT-98-000009) January 1998. The soil pit site was constructed in 1996 and consisted of both disturbed and undisturbed soil. Due to the highly packed clay lithology of the undisturbed portion of the site, grouting caused excessive grout returns and a general ground heave. The primary cause was insufficient void space in the soil to accommodate the injected grout. Further grouting of the undisturbed Soil Pit was abandoned and the grout material was excavated and removed. One section of the thrust block was moved to an area adjacent to the Soil Pit with disturbed soil. A series of grout injections through the thrust block into disturbed soil produced a large monolith. The large monolith was removed intact as a unit with a front end loader for further examination. The monolith was sent to the landfill in FY 1999.

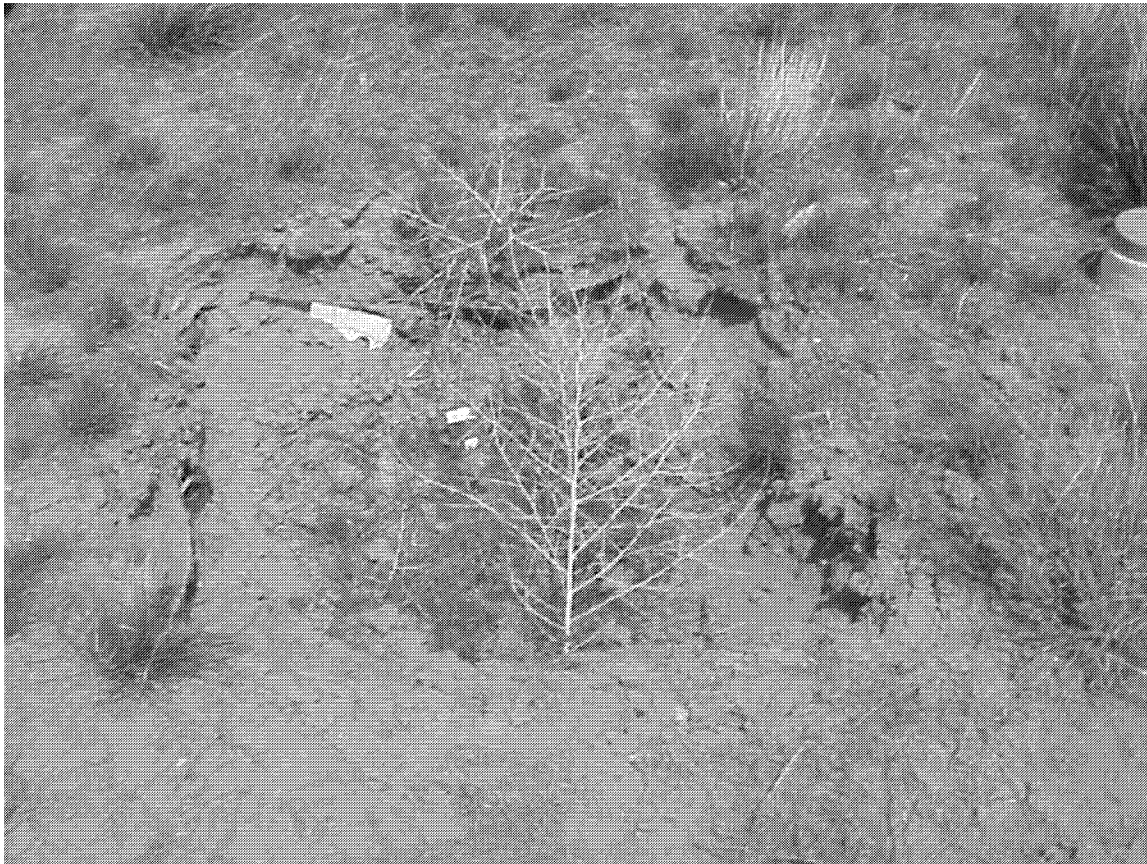
A small subsidence in the 1992 Characterization Cell (Now known as the “Calibration Cell”) was noted in May 2000. The subsidence was located at one end a 4×4×8 wooden box. The lid of the box had decayed to the point that the weight of the saturated overburden (saturation from spring melt) caused the lid to collapse at one end of the box. The time from placing material in the pit to the subsidence is eight years. During that time the lower area of the pit had undergone total flooding during the spring of xxxx. The total flooding added with the normal spring melt which left water standing in the area for 2-3 weeks in the spring, provided some ideal data for comparing material buried under more extreme conditions at the CTPS and those conditions at the SDA.
